# Manhole Inspection Summary

Manhole # S33II\_005MH

Insp Date: **3/30/07 11:26 AM**

**Location** Address: **1707 LANVALE ST**

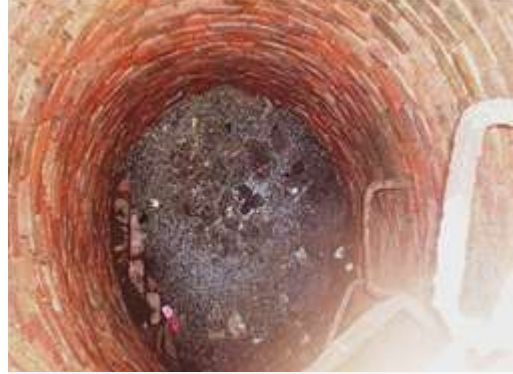
Top View

**Channel** Material: **Brick** ☐ Parged ☒ **Debris** (not Condition related)

**Steps** Count: **4** Missing: **0** ☒ **Corroded**

Corroded steps. Channel debris.

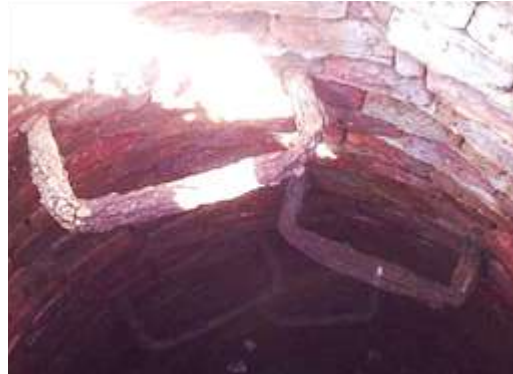
Defect

Condition: ☐ Sound ☐ Cracked ☐ Root Intrusion ☐ Loose Brick ☒ **Deteriorated**

Infiltration: ☐ None ☒ **Joint** ☐ Cracks ☒ **Mortar** ☐ Roots ☐ Wall

Corbel and Barrel deterioration and infiltration - other side.

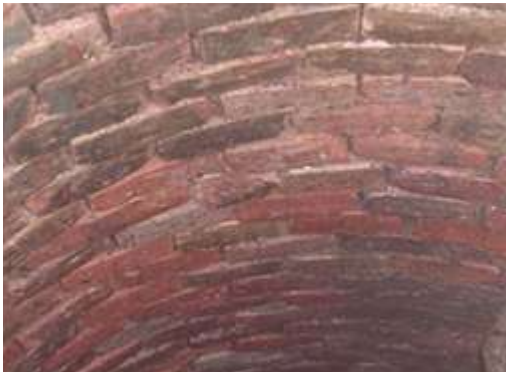
Defect

Condition: ☐ Sound ☐ Cracked ☐ Root Intrusion ☐ Loose Brick ☒ **Deteriorated**

Infiltration: ☐ None ☐ Joint ☐ Cracks ☒ **Mortar** ☐ Roots ☐ Wall

Corbel and Barrel deterioration and infiltration.

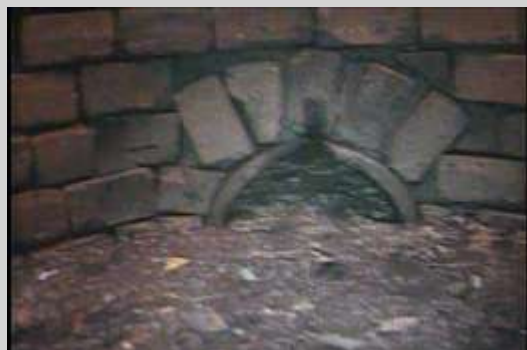
Pipe Out @ 12 O'Clock

Barrel deterioration and infiltration.

Deposits: ☐ None ☒ **Mud** ☐ Sludge ☒ **Debris** ☐ Grease

Pipe Seal Cond: **Broken**
